Professional Home Inspection Service

357 Deer Run Lane Forest City, NY 18520

Date of Inspection: 09/17/2012

INSPECTION REPORT PREPARED EXCLUSIVELY FOR Jack & Jane Doe

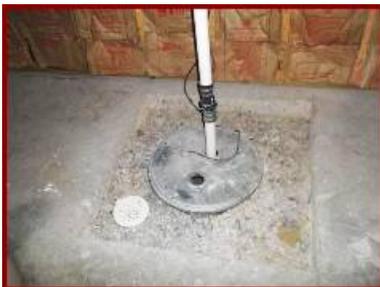
BASEMENT

INFO- A water control or drainage system was observed. This installation may have corrected a previous moisture entry condition.

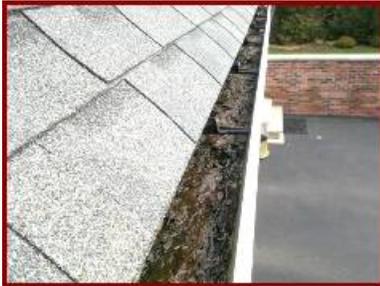
ROOF #1

MINOR- Gutter poorly pitched, *Further explain: Poor pitch is likely to result in clogging and overflow.*

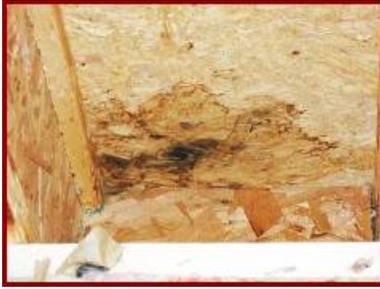
BASEMENT

MINOR- Water stain below dining room.

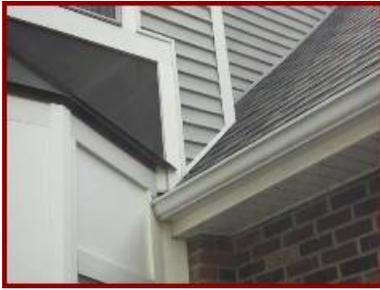
VISIBLE FLASHINGS

MINOR- Evidence of previous leakage at vulnerable location, Monitoring is recommended with any corrections or repairs as necessary.

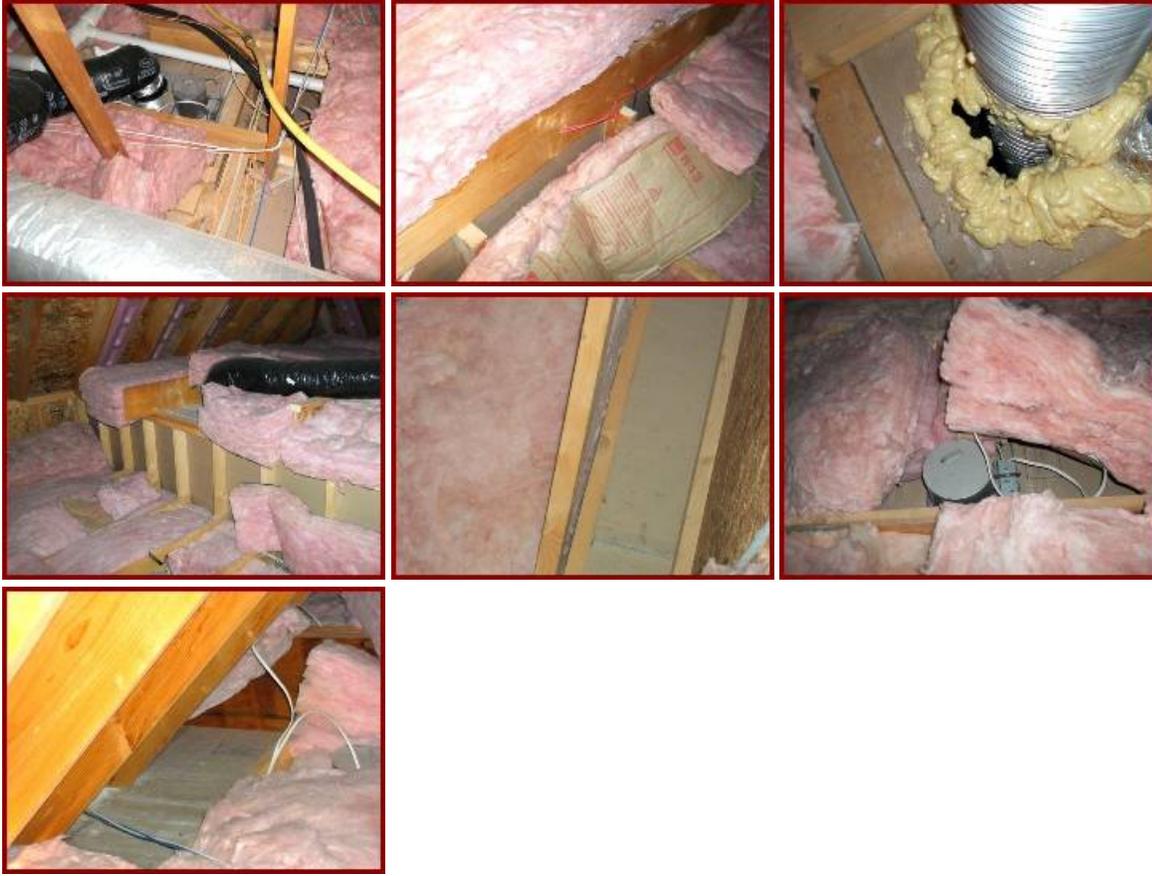
MINOR- Poor seal at attic access, Further Explanation: One or more attic access doors or scuttle openings are poorly sealed. We recommend improving the seal at the attic access to reduce heat loss.

Insulation missing, at several locations

Thermal bypass, at chimney chase(s)

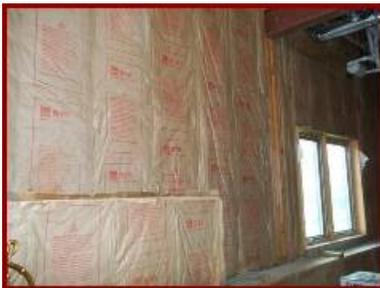
BASEMENT

MINOR- Exposed paper backing, *Further Explanation: The Kraft-face of some of the fiberglass insulation is uncovered. The manufacturer recommends covering the insulation to provide fire resistance. The greatest concern would be in areas near potential ignition sources, such as bare light bulbs. Common corrections include covering the Kraft paper, removing the paper or reversing the insulation, depending on the location.*

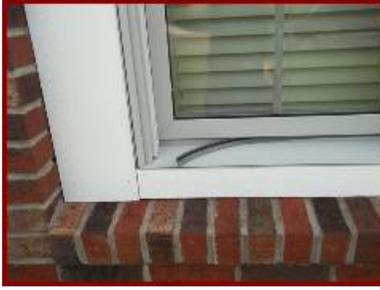
EXTERIOR: FRONT

MINOR-Loose weatherseal.

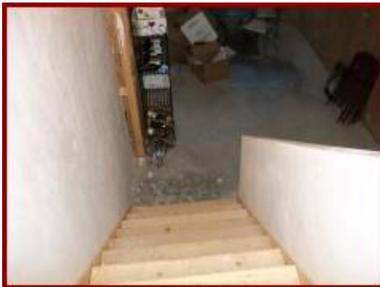
BASEMENT INTERIOR STAIRWAY

MINOR- Railing missing, at bottom, at steps, Further Explanation: Railings are missing that could improve safety and minimize trip-and-fall hazards.

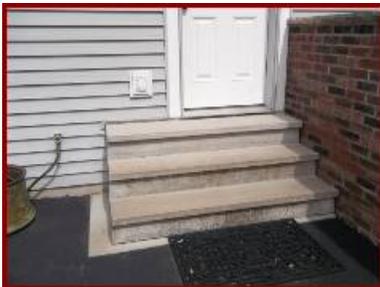
LEFT SIDE STEPS/STOOP

MINOR- Railing missing, at steps, Further Explanation: Railings are missing that could improve safety and minimize trip-and-fall hazards.

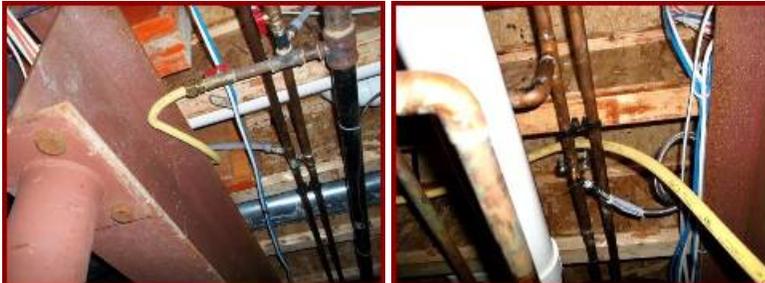
SAFETY- No direct electrical bond found for gas piping, *Further Explanation: Gas piping which includes corrugated stainless steel tubing, (CSST) does not appear to be properly bonded to the grounded electrode as required. Due to hazards associated with CSST gas piping, we recommend correcting this system per modern safety standards.*

CSST gas piping is in close proximity to wiring, ductwork, steel structural members, or metal plumbing piping, *Further Explanation: CSST gas piping is not permitted to be installed in close proximity to continuous electrically conductive materials. A two inch clearance is recommended.*

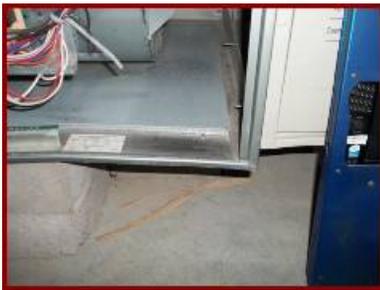
EXTERIOR HOUSING

MINOR- Poor support, deflection in unit.

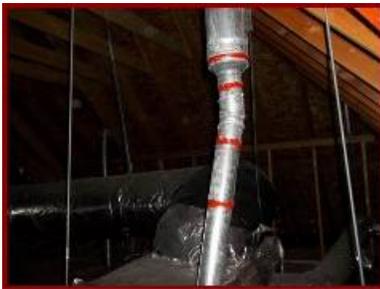
CHIMNEY OR VENT

MINOR- Single wall chimney in cold area, *Further Explanation:* Single wall metal vent pipe has inappropriately been used in the attic. This material will be prone to condensation build up and deterioration. Installing an appropriate chimney/vent connector is advised.

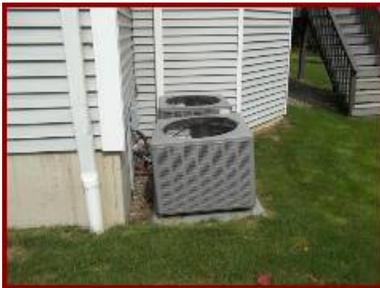
MINOR- Not level, Further Explanation: The condenser(s) is out of level. Leveling is recommended to ensure proper longevity of the unit(s).

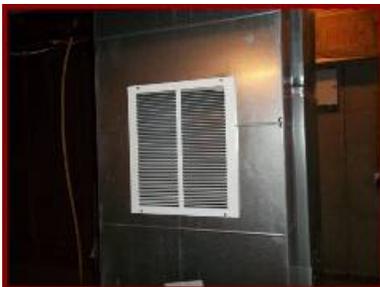
HEATING EQUIPMENT #1

SIGNIFICANT- Minimal return air sources, Further explanation: Insufficient return air to the furnace or air handler reduces heating or cooling efficiency and can result, in some circumstances, in harm to the heating or cooling equipment.

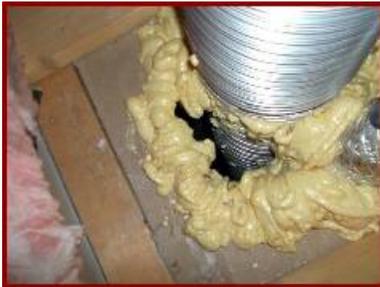
MAIN ATTIC

MINOR- Firestops missing, *Further Explanation: There is an unsealed chaseway opening(s) around the chimney or B vent. We recommend installing firestop at the floor framing and ceilings, per proper practice to help reduce the rate of flame spread in the event of a fire and to minimize heat loss.*

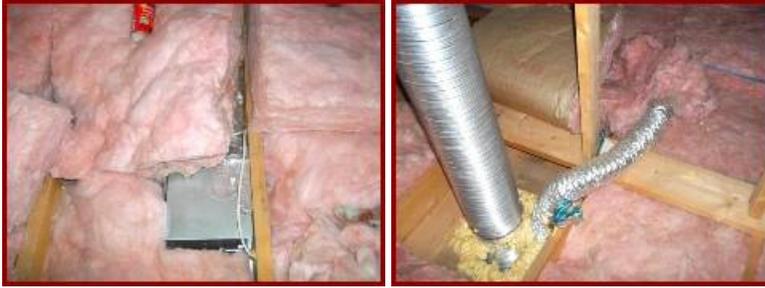
MAIN ATTIC

MINOR- Bathroom fan(s) vent into attic or soffits, *Further Explanation: One or more bathroom ventilators are believed to exhaust into attic space or the eaves. This can result in excess moisture buildup and possible damage. We recommend that ventilators exhaust directly to the exterior, per accepted practice.*

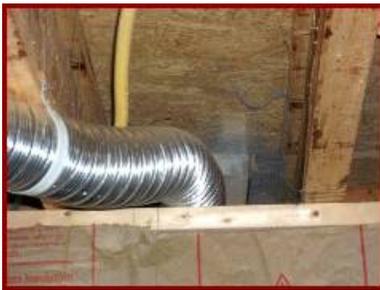
BASEMENT LAUNDRY

MINOR-Poorly sealed, lint buildup around duct.

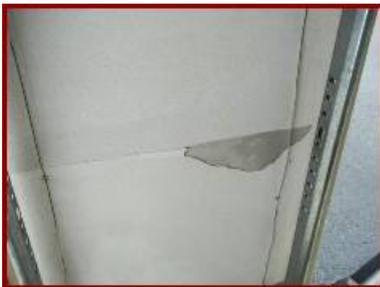
WALLS

MINOR- Minor cracks/stains/damage at one location.

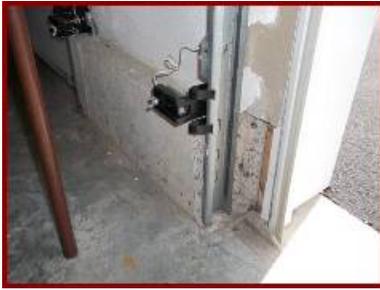
AUTOMATIC DOOR OPENER

MINOR- Poor photo cell placement. *Further Explanation: Photo cells for the garage door automatic reverse mechanism are not set close to the floor for maximum protection. The installation manual should be consulted for appropriate settings which usually approximate 5-6 inches off the floor.*
